18 East State Street
(Commercial Building)
Trenton
Mercer County
New Jersey

HABS No. NJ-965

ARCHITECTURAL DATA FORM

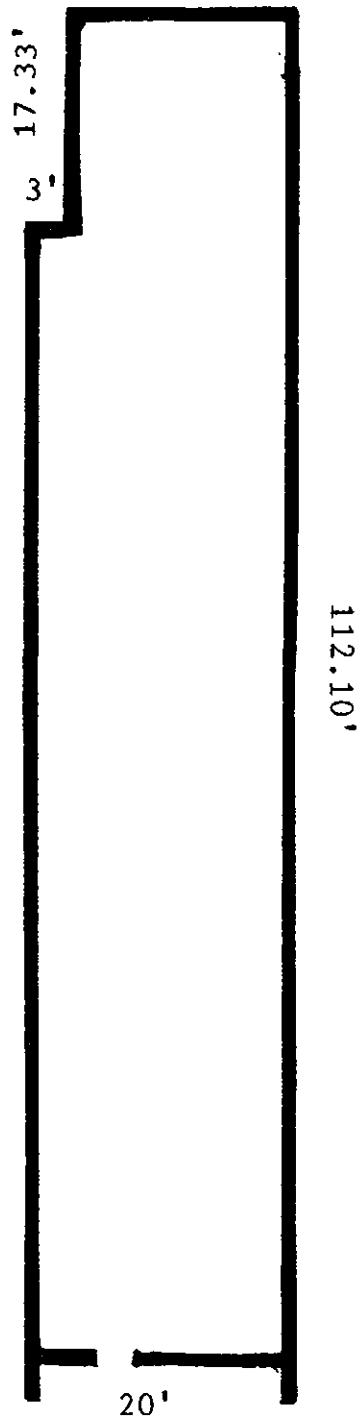
Floor Plan

SHAPE AND DIMENSIONS OF STRUCTURE (SKETCHED FLOOR PLANS ON SEPARATE PAGES ARE ACCEPTABLE) Rectangular building, approximately 20' x 112', four stories tall.			
EXTERIOR FEATURES OF NOTE White and tan color marbleized metal panels frame the storefront and extend halfway up the building. Facade windows at fourth floor only; 1/1 double hung sash windows flank a pair of similar type. There is no decorative trim; the windows share a plain continuous cornice & lintel. Tall parapet above flat roof.			
INTERIOR FEATURES OF NOTE (DESCRIBE FLOOR PLANS, IF NOT SKETCHED) Interior inaccessible at time of recording.			
MAJOR ALTERATIONS AND ADDITIONS WITH DATES White brick face applied to facade, probably mid-20th century. Large metal-framed windows and door to storefront added in 1970's.			
PRESENT CONDITION AND USE Fair condition. Building vacant on upper floors; first floor storefront in use. Building demolished September 1987 for redevelopment project.
